<b>BBTB Date:</b>	<b>13 April 2018</b>
<b>BBTB Number:</b>	<b>BBTB-009</b>
<b>BBTB Title:</b>	<b>OmniCare Fire Telephone Build Issue</b>
<b>System Description:</b>	<b>OmniCare</b>
<b>Product(s) Affected:</b>	<b>Fire Telephones manufactured between 11/2017 - 03/2018</b>
<b>Reference:</b>	<b>PRCR 1418</b>
<b>Priority:</b>	<b>I</b>

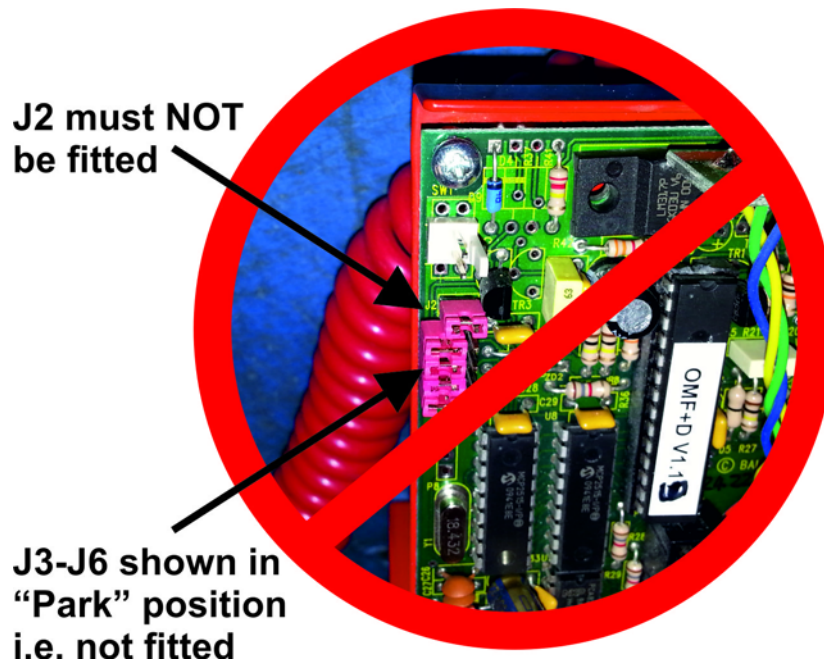
OmniCare Fire Telephone (BVOCFINT) Modules manufactured between November 2017 - March 2018 may have been supplied with J2 fitted.  
This link **should not** be fitted to the BVOCFINT module.

If link J2 is fitted the Fire Telephones will not respond correctly if a call is initiated from the Control Panel. When affected units are called and the Fire Telephone door is opened to answer the call, they will not stop ringing and a loud buzzing will be heard through the earpiece. A conversation cannot take place.

Figure 1 — Illustration showing J2 Incorrectly Fitted.

- Undo the two screws that hold the internal BVOCFINT module and carefully extract the module from the enclosure.
- Refer to Figure 1 for location of J2 and if fitted, remove it.

- Carefully refit the BVOCFINT Module into the enclosure and replace the two mounting screws.
- Perform another functional test and ensure the unit responds correctly to a call initiated at the control panel.  
Ensure a conversation can be held between the Operator and the Fire Telephone.

*It is not necessary to disconnect the unit from the site wiring or perform any other actions (e.g. Commissioning etc.) after removing J2.*
