<b>BBTB Date:</b>	<b>30 May 2019</b>
<b>BBTB Number:</b>	<b>BBTB-022</b>
<b>BBTB Title:</b>	<b>Care2 Firmware Update</b>
<b>System Description:</b>	<b>Care2</b>
<b>Product(s) Affected:</b>	<b>C2CB4, C2CB4(S), C2CS4, C2CBNEP, C2CSNEP using Firmware MCCNTPNL V4.02 supplied between 16 Nov 18 and 11 Apr 19</b>
<b>Reference:</b>	<b>ECR3630</b>
<b>Priority: I</b>	<b>I</b>

Baldwin Boxall has released Care2 Firmware MCCNTPNL V4.03.

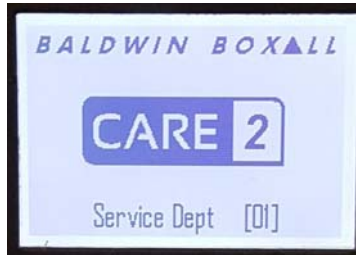
*Figure 1 — With the Handset door closed, ensure the display shows the Screensaver view*

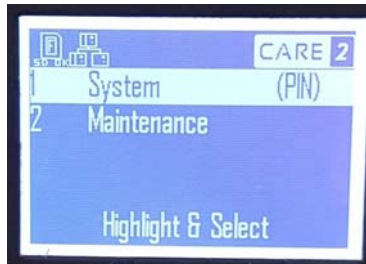
*Figure 2 — Press the Encoder and the System / Maintenance view is displayed*

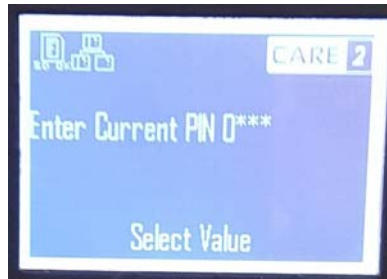
*Figure 3 — Press the Encoder to select the "System" menu (PIN Required)*

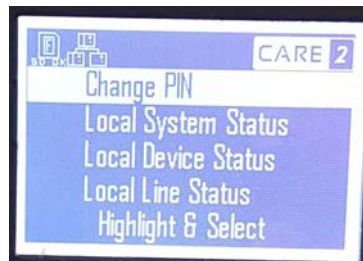
*Figure 4 — Enter the correct PIN to enter the System Menu (Default is 5555)*

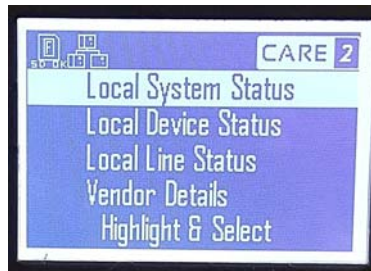
Figure 5 — Scroll down and select “Local System Status”

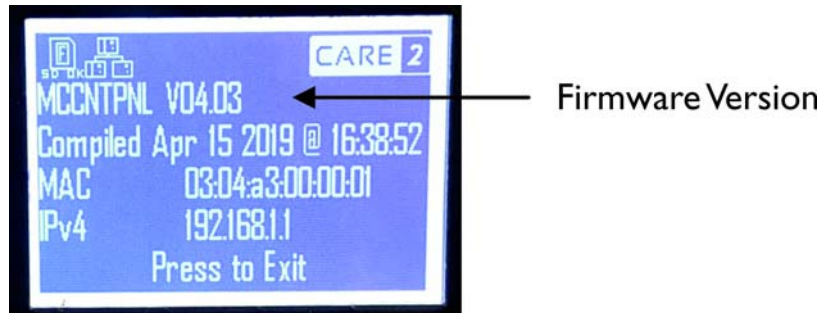
Figure 6 — The current Firmware Version will be displayed

If the MCCNTPNL version is shown as V04.02 then we recommend updating the firmware to V4.03.

Please supply a “Zero Value” Advance Replacement purchase order and Baldwin Boxall will provide a free of charge “Advance Replacement” main PCA that is configured with the updated V4.03 firmware.
