BBTB Date:	23 February 2021
BBTB Number:	BBTB-058
BBTB Title:	OmniCare Control Panels
System Description:	OmniCare Control Panel Internal Connections
Product(s) Affected:	BVOC32 - 64
Reference:	PRCR2347
Priority:	3

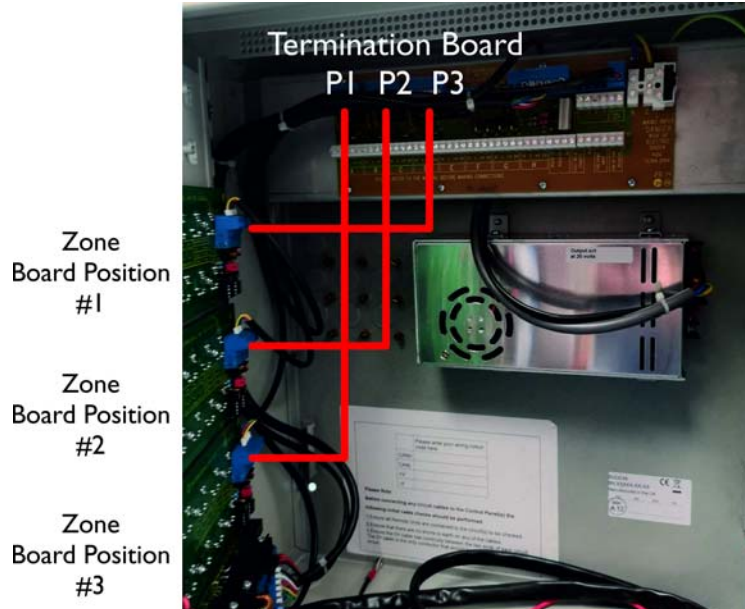
Figure 1 — Incorrect connection details

Baldwin Boxall has become aware of an issue with a small quantity of OmniCare Control panels built between October 2020 and February 2021. There was a build error in the internal connections between the zone PCB boards mounted on the door and the termination PCB mounted in the back box.

On affected units the connections on the front panel switch boards have been reversed, with P1 connected to the bottom board instead of the top board as shown in Figure 1. A 48 way panel has been used for these illustrations so there are three zone boards shown.

If it is deemed necessary to correct the internal connections perform the following:

- Power down the control panel by disconnecting mains & batteries.
- Disconnect the cables between the termination board and the front panel zone boards.
- Carefully reconnect the cables in turn, ensure P1 on the termination board is connected to the top zone board, P2 should then be connected to the next zone board down (for a 32 way panel), P3 to the third zone board down (for a 48 way panel) and P4 to the lowest zone board (for a 64 way panel). Refer to figure 2 for correct connection details.
- Reconnect the Batteries and reconnect the Mains power
- Perform commissioning and ensure the correct remote (the first remote unit connected to termination “A”) is identified as #1.
