BBTB Date:	24 Jan 2024
BBTB Number:	BBTB-110
BBTB Title:	CARE2 Background Noise Issue
System Description:	CARE2 Networked Systems
Product(s) Affected:	C2CB4 / C2CS4 / C2NEP
Reference:	PRCR3043
Priority:	3

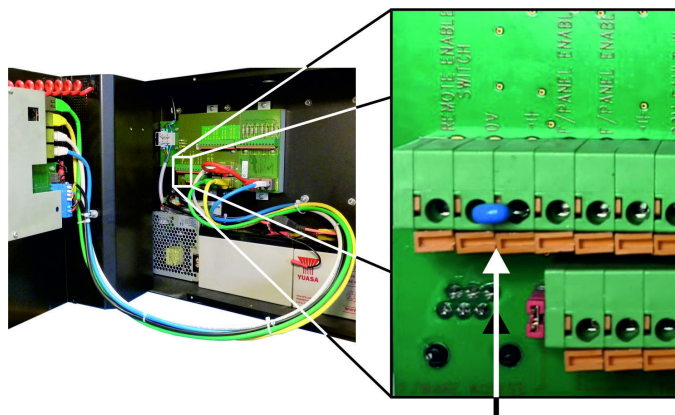
Figure 3 — Fit capacitor between 0V and GND on C2CN

Affected CARE2 installations may experience a higher than normal “50Hz” hum, audible in the handset in the background of all calls.

3. Using a suitable tool, push the orange spring clamps down and fit capacitor between 0V and GND on C2CN as shown in Figure 3. Release the clamps once the capacitor is fitted.

Fit capacitor between "0V" and "GND"
on the C2CN Network Card
